▶ CASE STUDY: GOVERNMENTAL APPLICATION

Keystone Saves Historic Homes From Failing Bluffs

- ▶ **PROJECT:** Natchez Bluff
- LOCATION:** Natchez, Mississippi
- PRODUCT:** Keystone Standard Units
- WALL DIMENSIONS:** 32’ (9.75 m) high X 280’ (85.34 m) long
- GENERAL CONTRACTOR:** Hayward Baker, Inc. Atlanta, Georgia
- ENGINEERING CONSULTANT:** Army Corps of Engineers Vicksburg, Mississippi
- KEYSTONE REPRESENTATIVE:** Keystone Southeast Baton Rouge, Louisiana

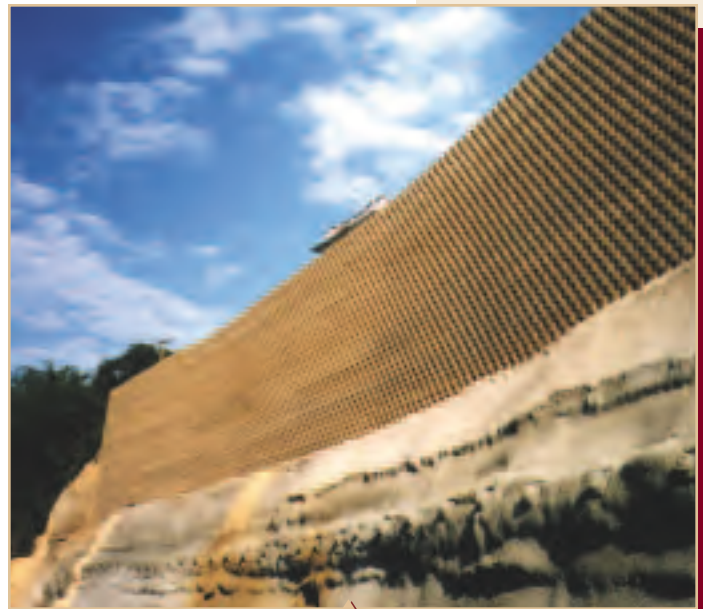
32’ High Keystone Wall solves the historic “Natchez Bluff” problem!

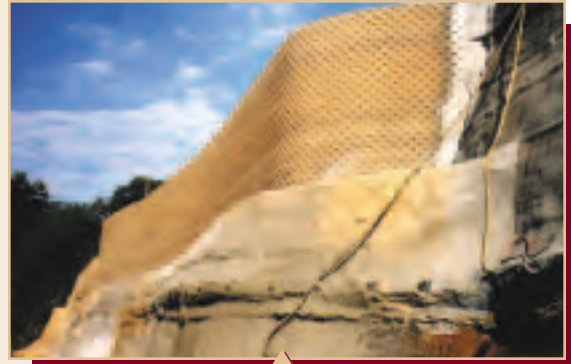
View of wall with soil nailed “bench” below.

“bench” or shelf 25’ out toward the river from the stabilized wall. The section above this bench was cut back 10 ft. (3.0 m) and the remaining area was stabilized with geogrid soil reinforcement and filled with 6,000 lbs. of lightweight aggregate, topped with sod and plants. One sidewall of the section is the original bluff, and the back wall of the section is the shotcrete-covered soil-nailed wall.

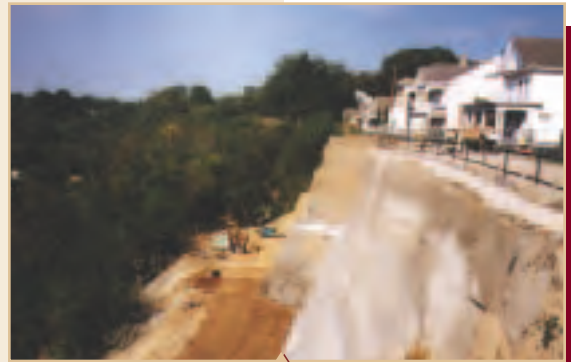
The top of the Keystone wall provides new front yards for bluff homeowners.
