▶ CASE STUDY: BARRIER APPLICATION

Keystone Rock Barrier Helps Save Lives

- ▶ **PROJECT:** New Mexico DOT
- LOCATION:** Rio Arriba County, NM
- PRODUCT:** Keystone Compac Units
- SQUARE FOOTAGE:** 2,160 s.f.
- CONTRACTOR:** Albuquerque Underground
Albuquerque, NM
- SPECIFIER:** MacCornack Engineering
Albuquerque, NM
- KEYSTONE REPRESENTATIVE:** Crego Block Co.
Albuquerque, NM

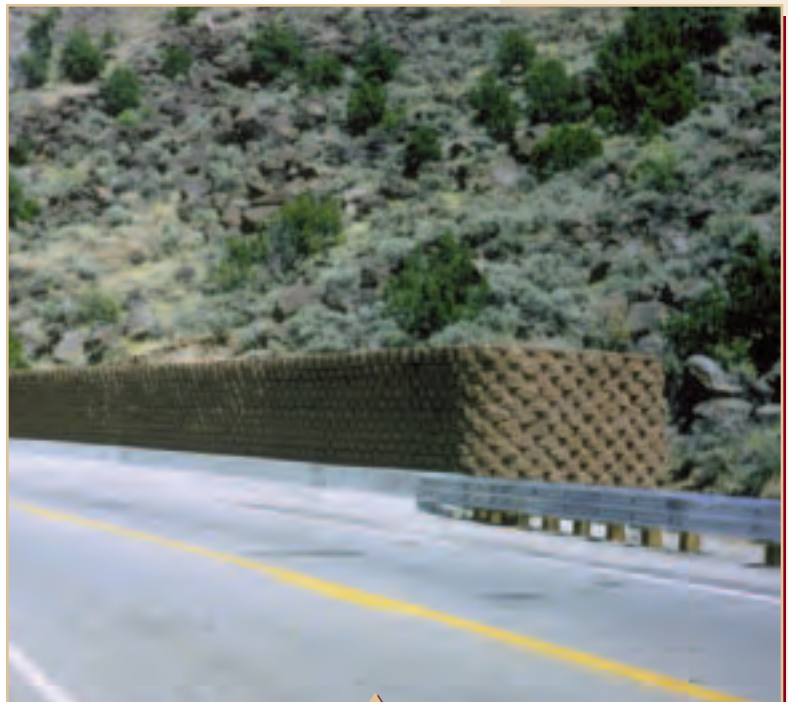
Keystone barrier wall, Rio Arriba County, New Mexico

Wall with a Keystone Retaining Wall System. Keystone offered structural integrity, ease of installation, aesthetic appeal and cost effectiveness. Albuquerque Underground constructed the reinforced wall with 2,160 Keystone Compac Units in Desert Beige color. The wall stands 12 feet high (3.7m) and 180 feet (54.8 meters) long. Reinforcement for the soil mass behind the Keystone wall consists of Mirafi's Miragrid 5T, 500X, 700X and 800X, soil reinforcing geogrid.

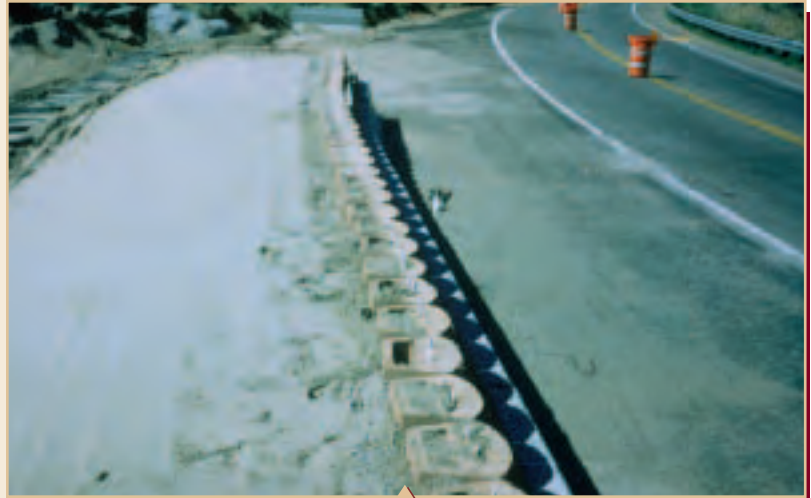
Falling rock barrier - Keystone wall facing the road, with reinforced soil zone behind, backed by wall of old tires.

Working with MacCornack Engineering, NMDOT designed a barrier wall to stop falling rocks from reaching the road. The design called for a two sided retaining wall; one conventional wall facing the roadway and a second wall of stacked, discarded tires facing the hillside. The space between the two walls consisted of a geogrid reinforced soil zone of 10 feet (3m). Between the stacked tire wall facing and the hillside was an open catchment area which trapped the falling rocks after striking and rebounding off the tire faced barrier.

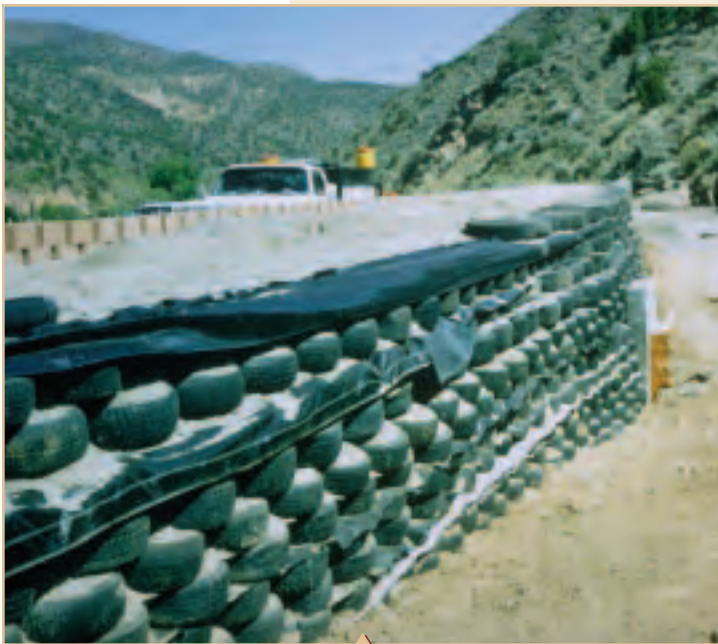
Tire wall at back of the barrier, cushions falling rocks and directs them into the catchment area.

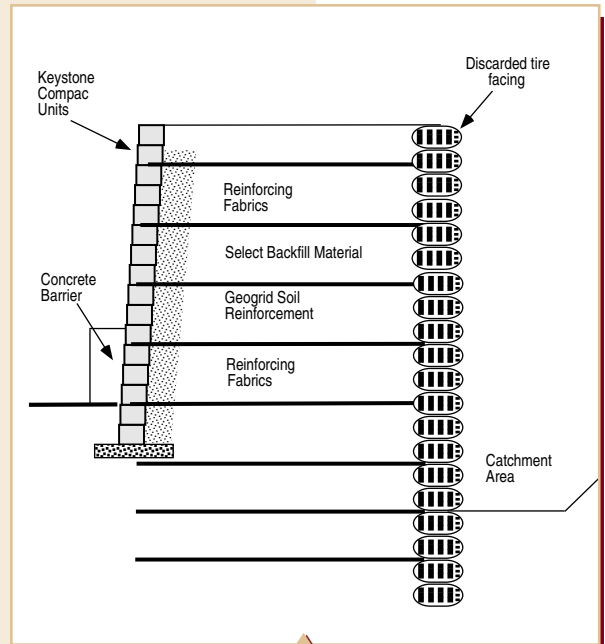
Rock barrier typical cross section.
